SERIOUS INCIDENT
RESPONSE TEAM

Summary of Investigation

SiRT File # 2024-013

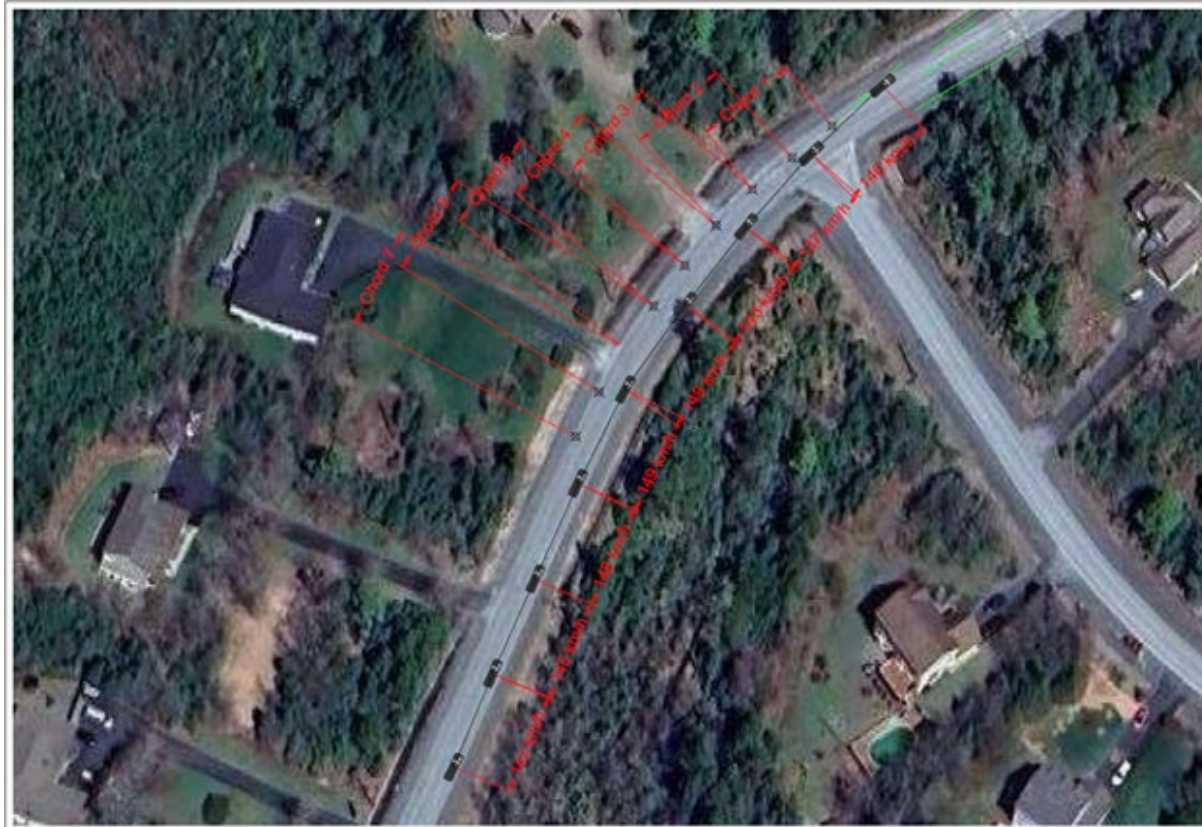
The report author noted that it was their opinion that the AP's vehicle was travelling 139 km/h 1.0 seconds before the collision and as high as 149 km/h 3 seconds before the collision. The report found that the critical curve velocity of the road was 90 km/h and the AP's vehicle was exceeding that critical curve velocity. This is illustrated by the following graphic from the CARS report:

Crash data equipment software shows that the AP's vehicle speed ranged from 118km/hr to 149 km/hr in a 50 km/hr zone. In the five seconds before the collision to 0.5 seconds before the deployment of airbags, the engine throttle position was at 99% of full throttle. It is recorded that the driver safety belt was not buckled. The Airbag Control Module recorded two events: the first was a rollover and the second was a front and left event.

The civilian Senior Forensic Engineer and Collision Reconstructionist expert noted that the crash data report from the AP's vehicle shows that it was travelling at speeds in excess of 140 kph in the moments leading up to the crash, in a 50 kph speed zone. He also noted the vehicle exited on the left side of the roadway which is a typical result of driving too fast in a curve. This independent expert agreed with the findings of the RCMP CARS report. GPS data shows that the highest speed reached by the SO's vehicle 100 km/hr.
